Client: Burntwood Town Council

Location: Coulter Lane Burial Ground

Date: 14.4.09

Remit: Initial walkover inspection of trees within the burial ground.

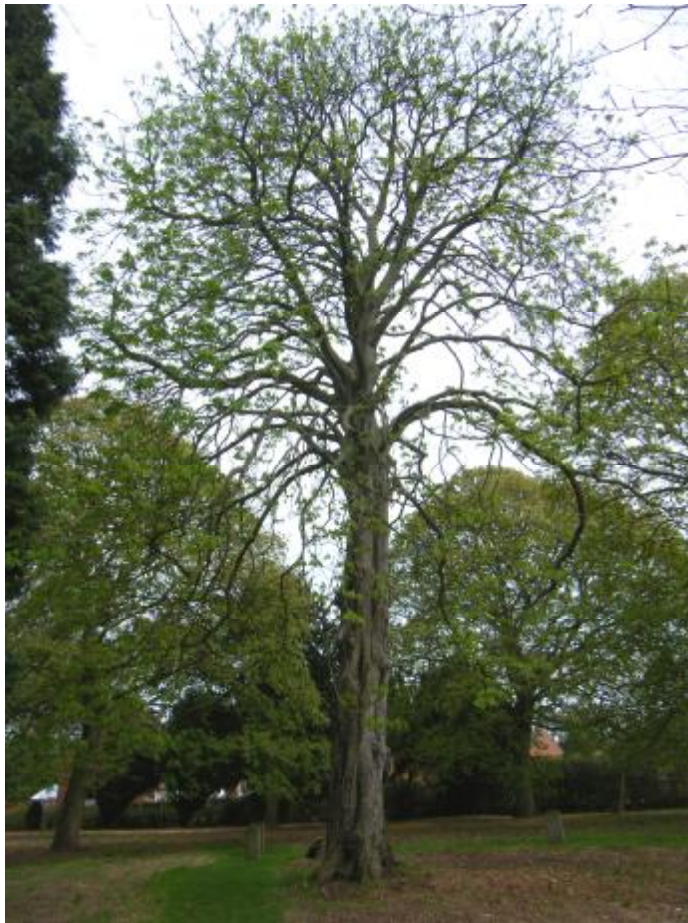
T1: Late-mature Horse Chestnut.

Evidence of bleeding canker of Horse chestnut and Honey fungus infection.

Both pathogens will destroy the tree vascular system resulting in crown dieback and eventual death. The loss of foliage volume will reduce the trees capacity for compensatory growth response to decay. The species lacks durable heartwood and is therefore at risk of structural failure in the advanced stages of decay.

Evidence of recent storm damage to 2nd order limb in the upper crown.

Risk assessment: The tree is open grown with a relatively unrestricted rooting zone which will prolong stability. Public access to the site is restricted.

Recommendation: the tree is in a spiral of decline. Complete a bat inspection and consider dismantling the tree a the end of the bird nesting season 2009

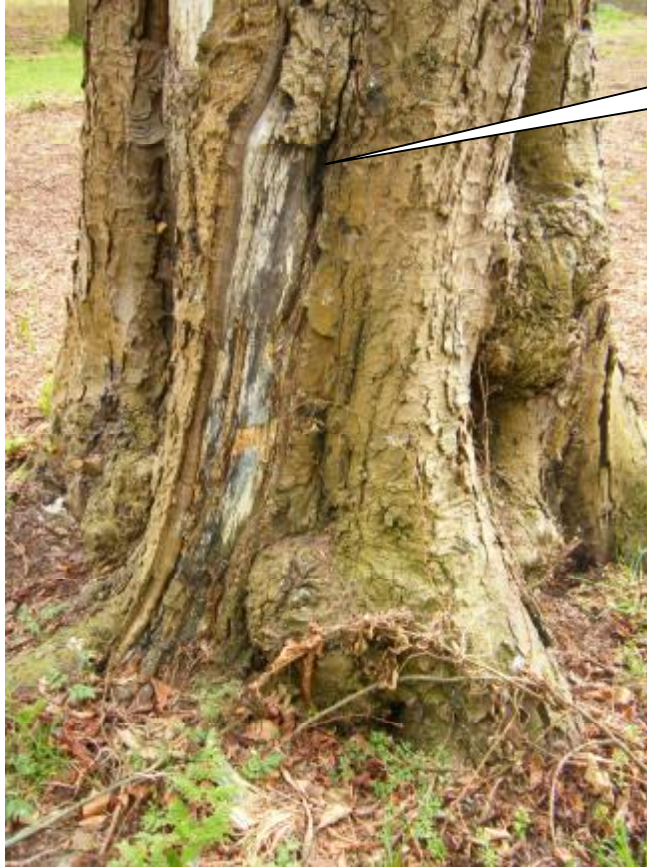
T1: Bleeding canker lesions and honey fungus rhizomorph

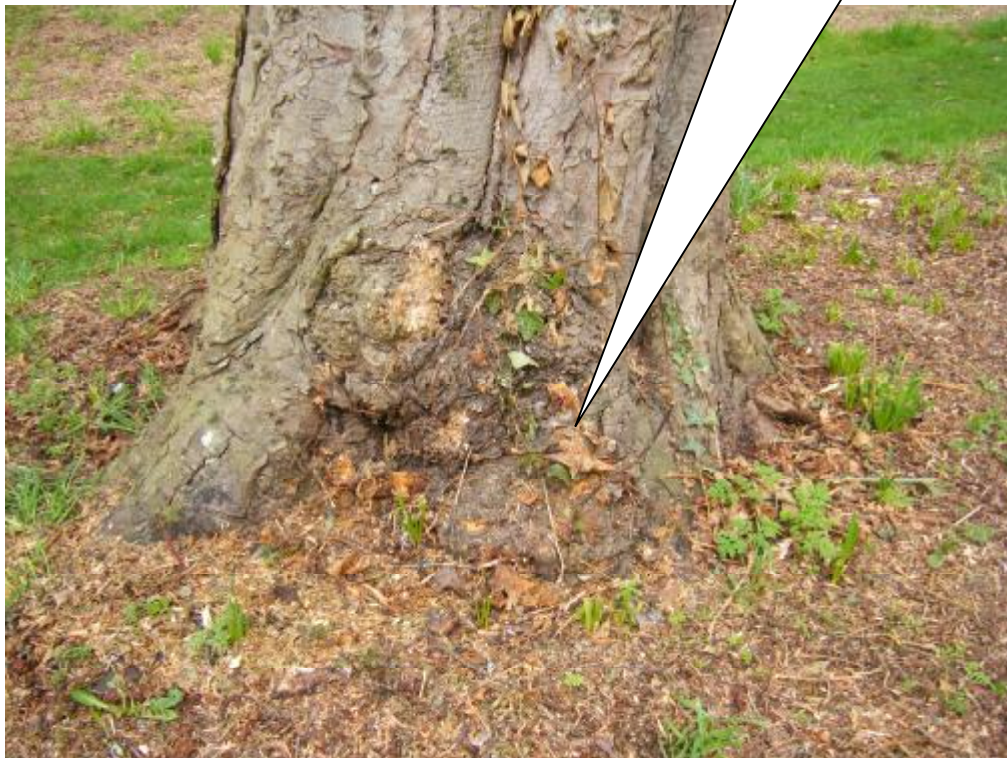
T1: Denatured fungal fruiting bodies, probably of Honey Fungus

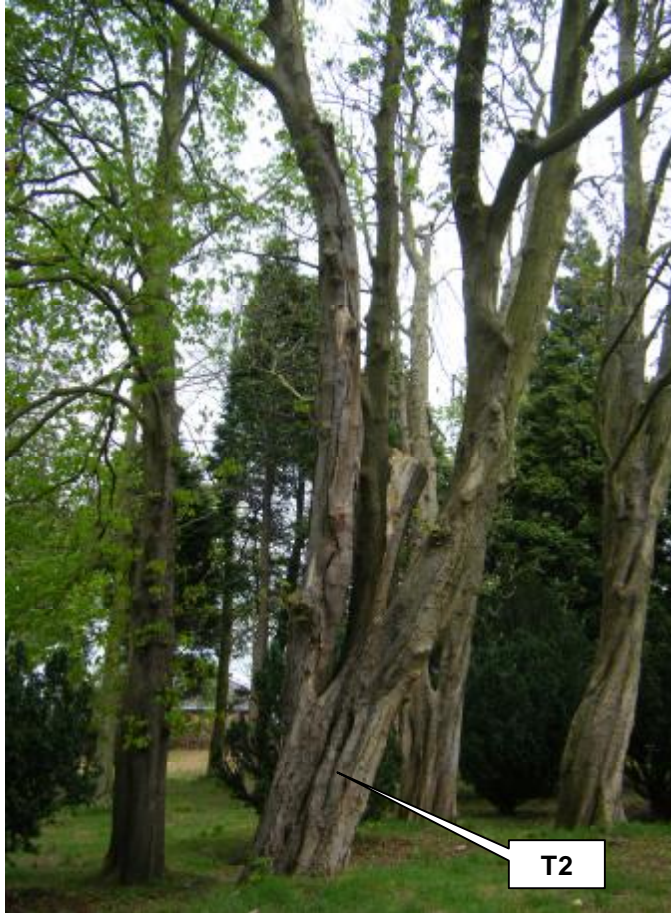
T2: Late-mature Horse Chestnut.

Evidence of bleeding canker of Horse chestnut and Honey fungus infection. Both pathogens will destroy the tree vascular system resulting in crown dieback and eventual death. The loss of foliage volume will reduce the trees capacity for compensatory growth response to decay. The species lacks durable heartwood and is therefore at risk of structural failure in the advanced stages of decay. Multiple pruning wounds have resulted in death of vascular tissue in the scaffold limbs.

Risk assessment: The tension side of the tree root zone is infected with Honey fungus and the tree is weighted to the south. Public access to the site is restricted.

Recommendation: the tree is in a spiral of decline. Complete a bat inspection and consider dismantling the tree at the end of the bird nesting season 2009

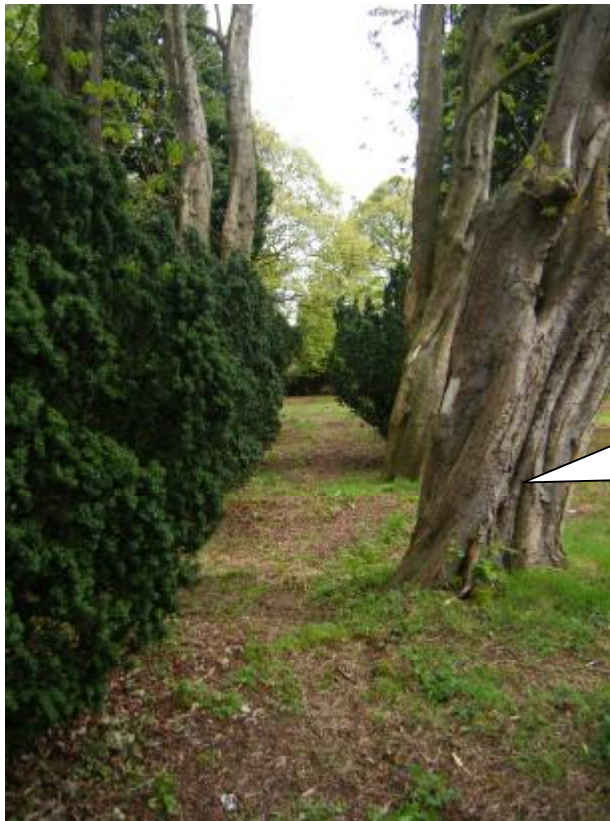
T2: Forms part of an avenue of alternating yew and H. chestnut.

(Insufficient growing space between the two lines has resulted in a phototropic growth response)

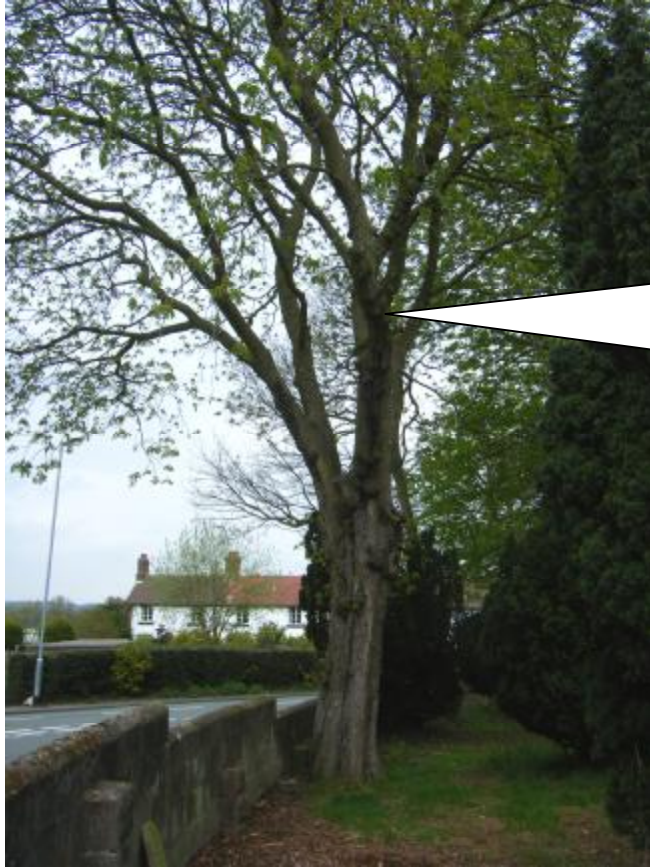
T3: Localised decay in underside of limb aligned parallel with the boundary wall.

Risk assessment: potential for structural failure

Recommendation: Close inspection by climber, review risk assessment and consider end reduction of limb to relieve loading stress

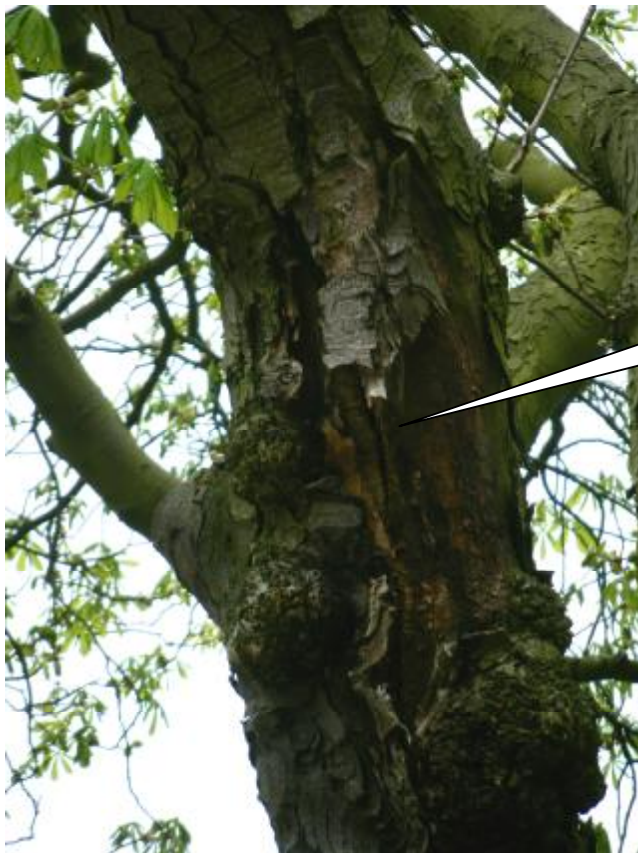
T3: Localised decay in underside of limb aligned parallel with the boundary wall. Evidence of longitudinal crack in exposed wood and woundwood response
